Tornado Protection

Selecting Refuge Areas in
Buildings

FEMA P-431, Second Edition / October 2009

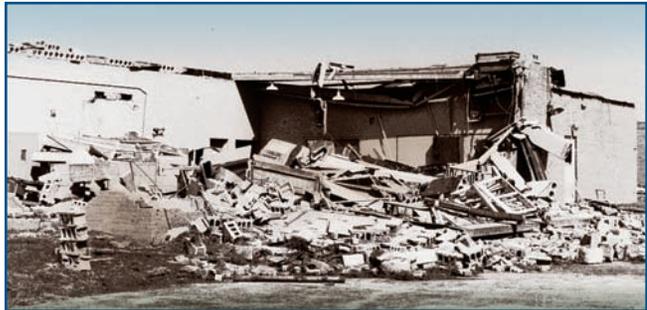
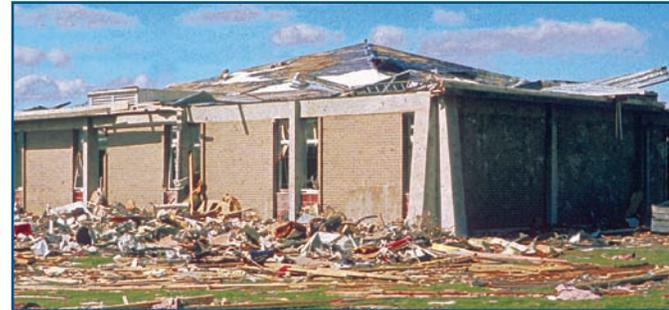
Figure 1-6
Typical tornado rotation.

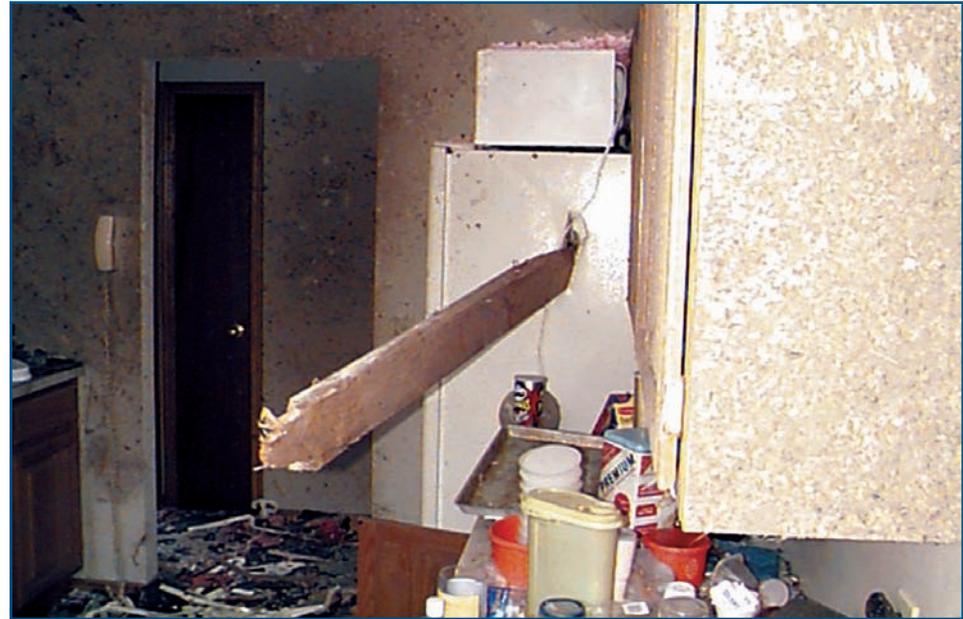
Figure 2-3
Example of severe damage from a windborne missile. This metal door was pushed inward by the impact of a heavy object.

The extreme winds in tornadoes pick up and carry debris from damaged buildings and objects located in the path of the winds (see Figures 2-2 and 2-3). Even heavy, massive objects such as cars, tractor trailers, and buses can be moved by extreme winds and cause collateral damage to buildings. Light objects become flying debris, or missiles, that can penetrate doors, walls, and roofs; heavier objects can roll and cause crushing-type damage.

Damage was also caused by the impact of windborne missiles. Figure 2-3, in Chapter 2, shows a steel door that appeared to have been opened by the impact of a heavy object. This door led into an area where the roof was missing. The opening created by this breached door may have allowed wind to enter the building and create internal pressure that increased the load on the building envelope. Figure 3-22 shows damage to a laminated glass window hit by a table.

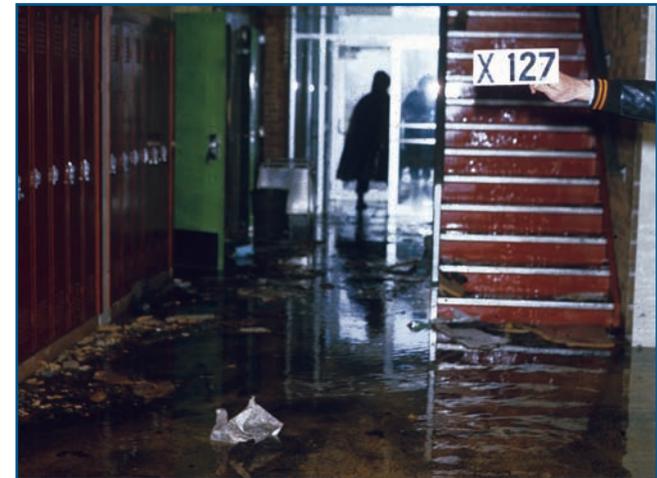
Figure 3-3
Surviving interior hallway. This is an example of the type of area that may provide refuge for building occupants during a tornado.

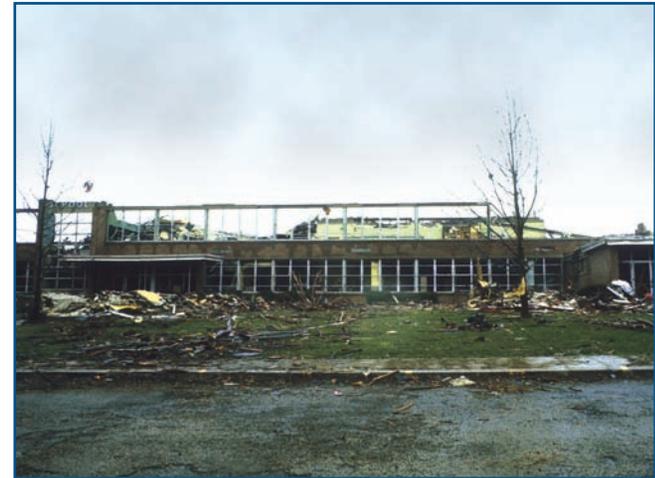
Figure 3-5
Loss of lightweight roof over the original two-story building.

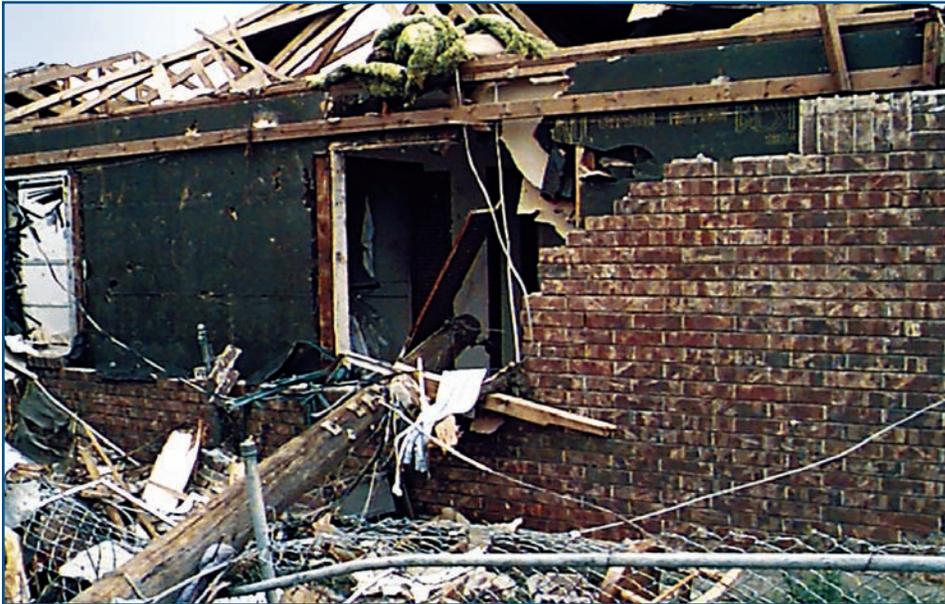
Figure 4-4
This power pole penetrated a window and extended several feet into the house after being blown 40 feet from its original location.
